REPORT DOCUMENTATION PAGE		READ INSTRUCTIONS BEFORE COMPLETING FORM
1. REPORT NUMBER	2. GOVT ACCESSION NO.	3. RECIPIENT'S CATALOG NUMBER
4. TITLE (and Subtitle) Phase I Inspection Report Newton Hoffman Creek No. 1 Dam Chemung River Basin, Chemung County, NY Inventory No. 547		5. TYPE OF REPORT & PERIOD COVERED Phase I Inspection Report National Dam Safety Program

Assessment - Newtown-Hoffman Creeks Watershed Project - Floodwater  
Retarding Dam Site 1

PHASE I INSPECTION REPORT  
NATIONAL DAM SAFETY PROGRAM  
NEWTOWN-HOFFMAN CREEKS WATERSHED PROJECT -  
FLOODWATER RETARDING DAM SITE 1  
N.Y. 547  
DEC I.D. NO. 67A-3974  
CHEMUNG RIVER BASIN  
CHEMUNG COUNTY, NEW YORK

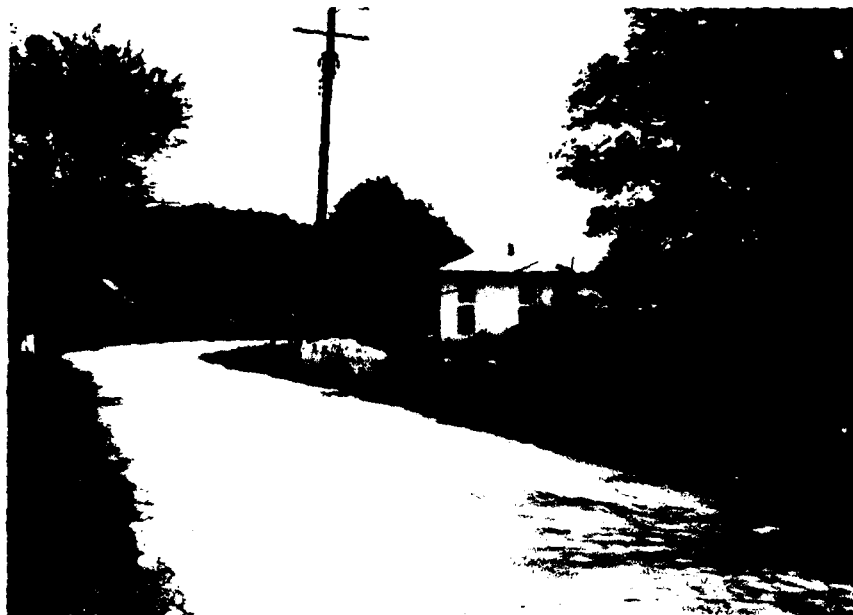
The dam is classified to be in the high hazard category. About one mile downstream, Newtown Creek flows through a rural residential area which is considered to be within the potential floodplain of Newtown Creek.

PHOTOGRAPH NO. 5  
Rural Residential Area  
(0.6 mile downstream)

1. An emergency action plan should be developed, including a formal warning system to alert the downstream residents in the event of an emergency.

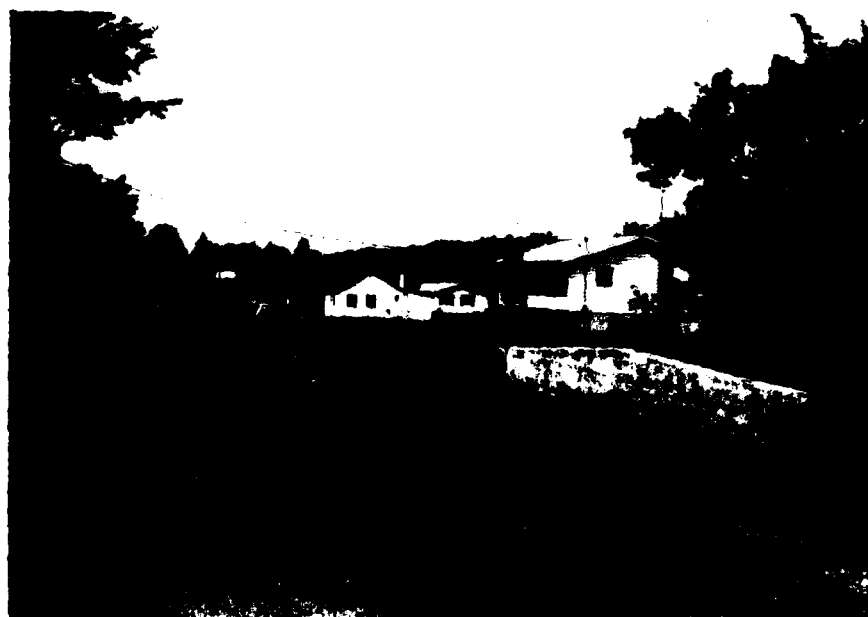
PHOTOGRAPH NO. 6  
Rural Residential Area  
(1.0 mile downstream)

- a. Downstream Hazard (No. of Homes, Highways, etc.) Rural  
residential area (10-15 homes) approximately one mile  
downstream of the dam.
- b. Seepage, Unusual Growth None
- c. Evidence of Movement Beyond Toe of Dam None
- d. Condition of Downstream Channel Good
